Manhole Inspection Summary

Manhole # S51I__008MH

Insp Date: **4/2/08 2:39 PM**

Location Address: **500 Streeper St**

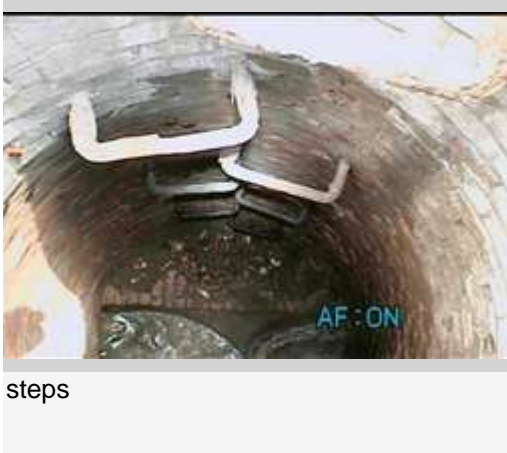
Defect 1

Count: **7** Missing: **0** ☒ **Corroded**

steps

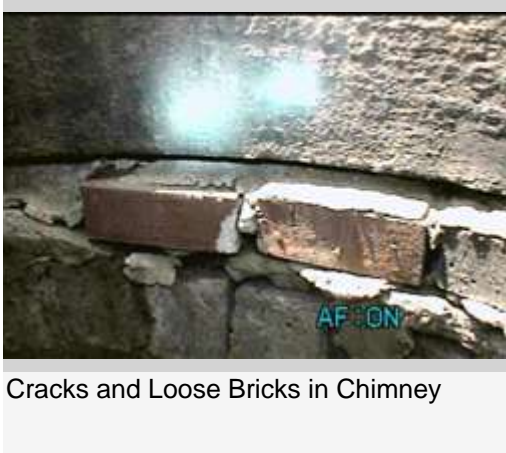
Defect 4

Condition: ☐ Sound ☒ **Cracked** ☐ Root Intrusion ☒ **Loose Brick** ☐ Deteriorated

Cracks and Loose Bricks in Chimney

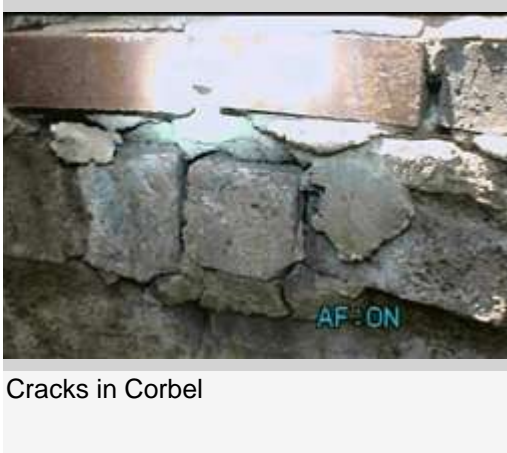
Defect 3

Condition: ☐ Sound ☒ **Cracked** ☐ Root Intrusion ☐ Loose Brick ☐ Deteriorated

Cracks in Corbel

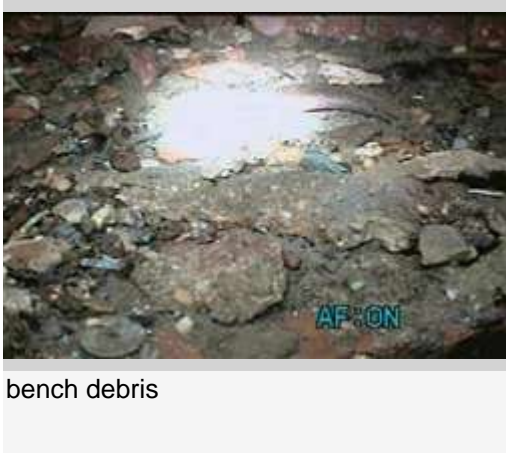
Defect 2

Condition: ☐ Sound ☐ Cracked ☐ Root Intrusion ☐ Deteriorated ☐ Leaks ☒ **Debris**

bench debris

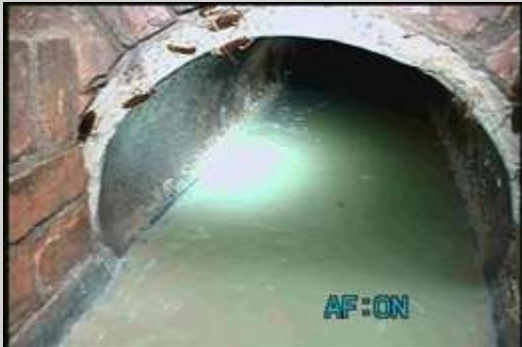
12 O'Clock Outflow

15 in. Circular Gravity Sewer
Pipe Out @ 12 O'Clock

Infiltration: **Dripper** Pipe Seal Cond: **Unknown**
